**DEPARTMENT OF TRANSPORTATION**

Contract #: 04-0120F4Cty: SF/ALA Rte: 80 PM: 13.2/13.9File #: 69.28**WELDING INSPECTION REPORT****Resident Engineer:**Pursell, Gary**Address:** 333 Burma Road**City:** Oakland, CA 94607**Report No:** WIR-002703**Date Inspected:** 26-May-2008**Project Name:** SAS Superstructure**OSM Arrival Time:** 700**Prime Contractor:** American Bridge/Fluor Enterprises, a JV**OSM Departure Time:** 1700**Contractor:** Zhenhua Port Machinery Company, Ltd (ZPMC), Changxing Island **Location:** Shanghai, China**CWI Name:** Sun Wei**CWI Present:** Yes No**Inspected CWI report:** Yes No N/A**Rod Oven in Use:** Yes No N/A**Electrode to specification:** Yes No N/A**Weld Procedures Followed:** Yes No N/A**Qualified Welders:** Yes No N/A**Verified Joint Fit-up:** Yes No N/A**Approved Drawings:** Yes No N/A**Approved WPS:** Yes No N/A**Delayed / Cancelled:** Yes No N/A**Bridge No:** 34-0006**Component:** OBG**Summary of Items Observed:**

## WELDING INSPECTION REPORT

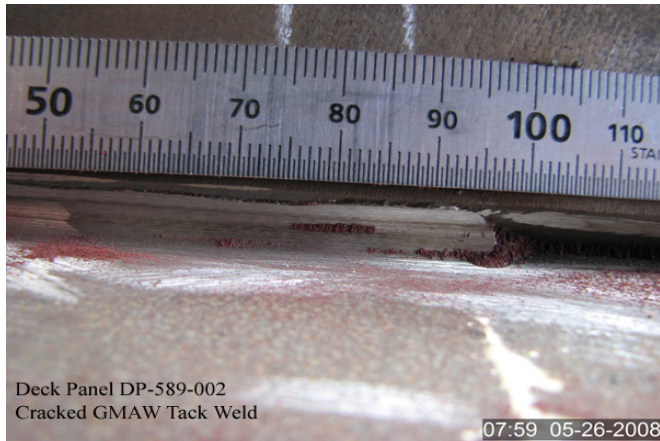
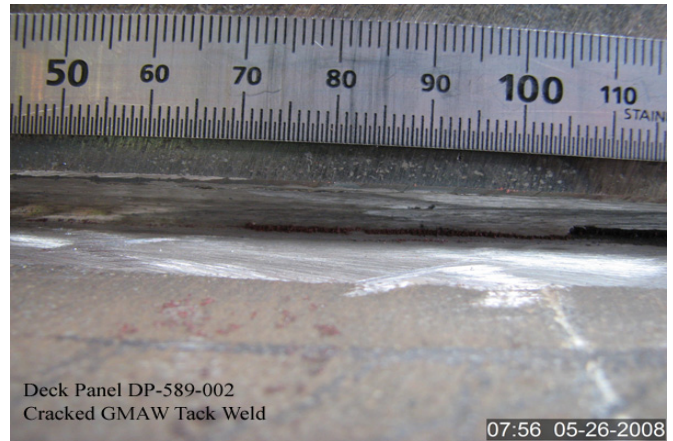
The Quality Assurance Inspector performed magnetic particle inspection to the tack welds on weld 8 of Deck Panel DP-589-002. Weld 8 contains 24 tack welds. Of the 24 tack welds, 16 appeared to contain linear indications indicative of cracks. ABF representative Warren Buehler was notified by the Quality Assurance Inspector. Mr. Buehler stated that ABF has recommended that all the tack welds be magnetic particle tested. At completion of the Quality Assurance Inspectors shift ABF had begun magnetic particle testing weld 8. Below are two digital photographs of cracked GMAW tack welds located by the magnetic particle testing method.
